MANDATORY BULLETIN - *draft*

No BO-16/07 MDM-1 FOX/ MDM-1P FOX-P

CONCERNS: Canopy hinge

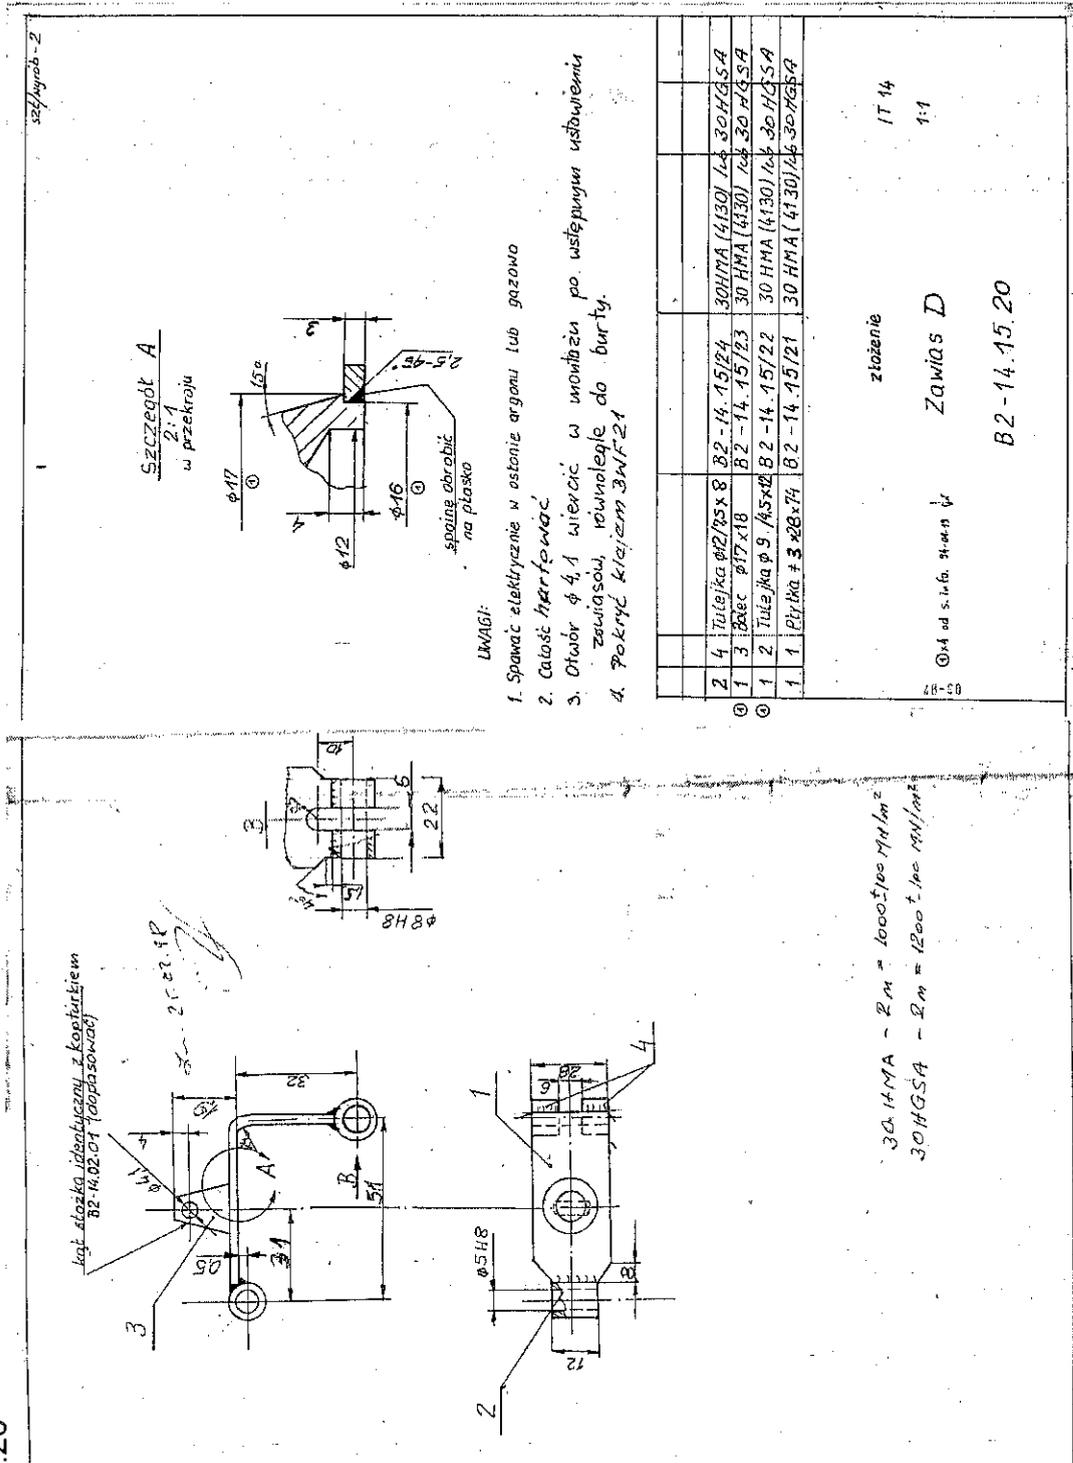
3. Dwg No B2-14.15.20

At the glider inspection, on several (4+1) MDM-1 FOX gliders, the cracks in the area of welded joint between the attachment cone and hinge plate (Dwg. No. B2-14.15.20) have been found at the canopy gas-spring attachment points on front&rear cockpit canopy.

Action 2. (a) If evidence of cracks in welded joint area has been detected at the hinge, the attachment cone must be re-welded to hinge plate – as per instruction in the Enclosure No 1 to this Bulletin.

1. Disassemble the hinge from canopy
2. Clean the whole welded joint thoroughly
3. Verify the detail against next/ other mode cracks and damages
4. Re-weld the cracked area with thorough penetration, extending the area of penetration slightly beyond the edge of visible crack
5. Detail hardening operation/ 880 deg C – oil
6. Detail tempering operation/ 540 deg C – water or oil / 27-33 HRC hardness
7. Clean the welded area from scale
8. Protect the detail with anti-corrosion paint.
NOTE: do not paint the openings and conical surface
9. When assembling, cover the non-painted surface with grease
10. As a result of hardening, the increased clearance at opening- and conical mating surface may appear.
11. Welding by TIG inert gas method
