## SERVICE BULLETIN No BO-20/2013 MDM-1 FOX

DESIGNATION-TYPE/MODEL: MDM-1 FOX

SERIA / NUMBER: S/Nos: P-11 through P-16, and 201 through 239 inclusive  
variants: MDM-1 FOX, MDM-1P FOX-P, MDM-1M FOX

CONCERNS: verification of bonded joint between wing upper skin and spar  
by "tap-test"

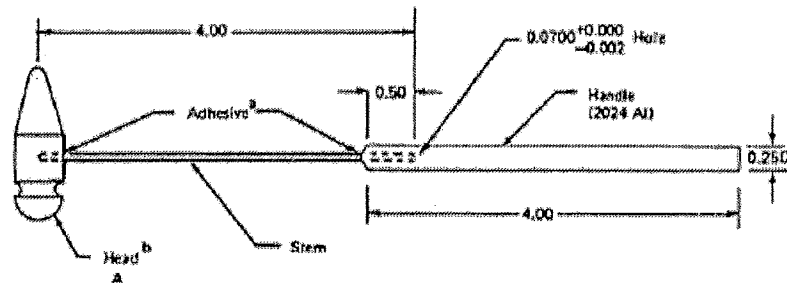
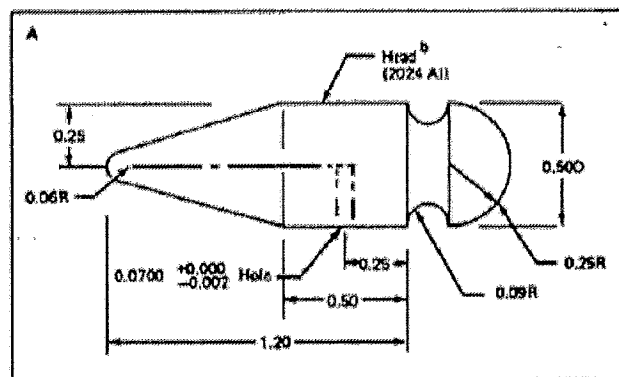
Sketch No 1 Tap-test hammer

1. Disassemble the wings from the glider and support the verified wing panel horizontally on stable, vibration suppressing foundation – upper surface on top.
2. The verification is to be accomplished in a quiet area/ room
3. It is recommended to make the tap test with a "hammer" (sketch No 1 below) – however a bolt or coin (weight below 50 g) can give satisfying results.

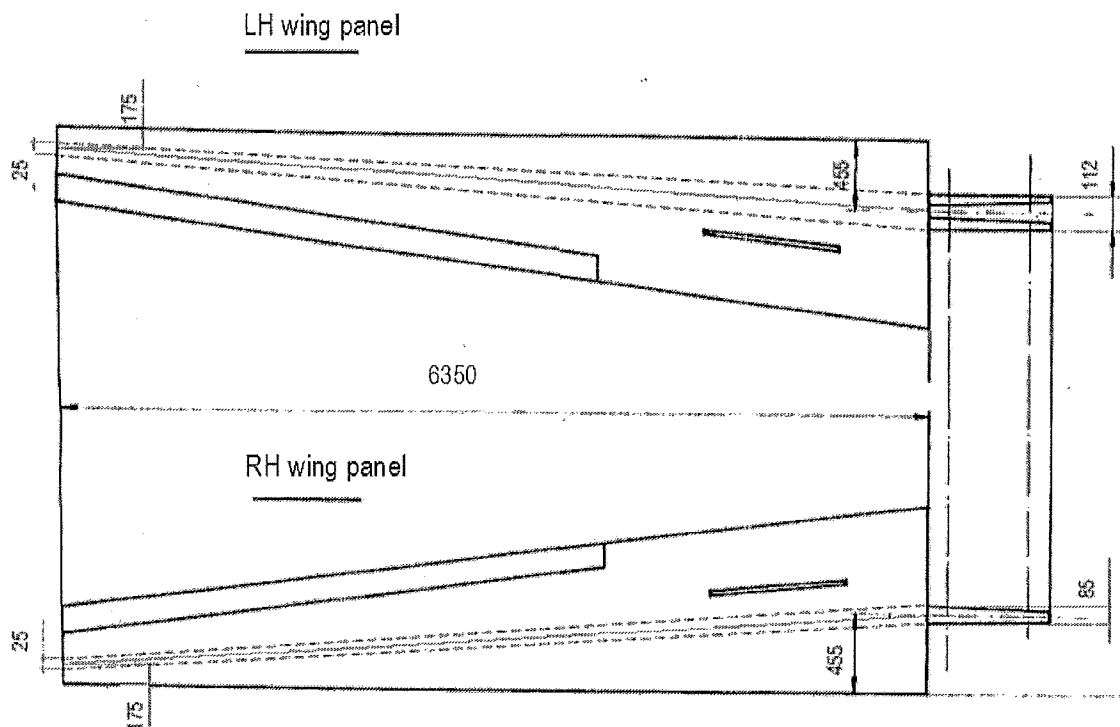
Sketch No 2 Inspected area on upper surface of LH/ RH wing

4. Prior to test, on wing upper surface contour with dashed line the area of bonded joint to be verified, as in the sketch No 2 below. Note there are different chordwise dimensions on LH and RH wing panels

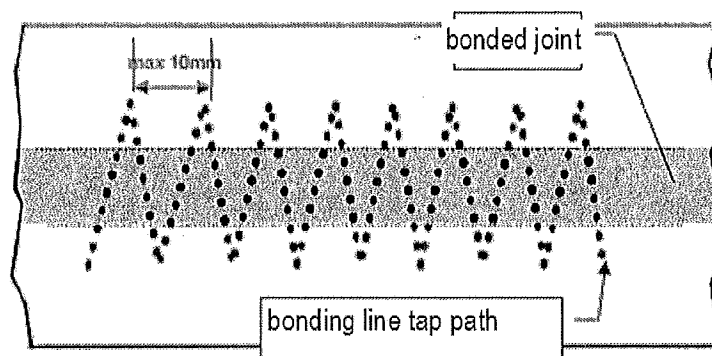
Sketch No 3 Suggested path for tapping the bonded joint

8. The bonded joint is to be tap-tested over the whole width and span, with subsequent strokes spaced evenly (see sketch No 3).
