Bulletin No 01/95 MDM1-FOX

BULLETIN No BE 01/95 MDM1-FOX**Concerns:**

In part "A" - limiting the range of elevator trim deflection.

In part "B" - strengthening of skeleton elements-to-shell bonding in fuselage tail portion.

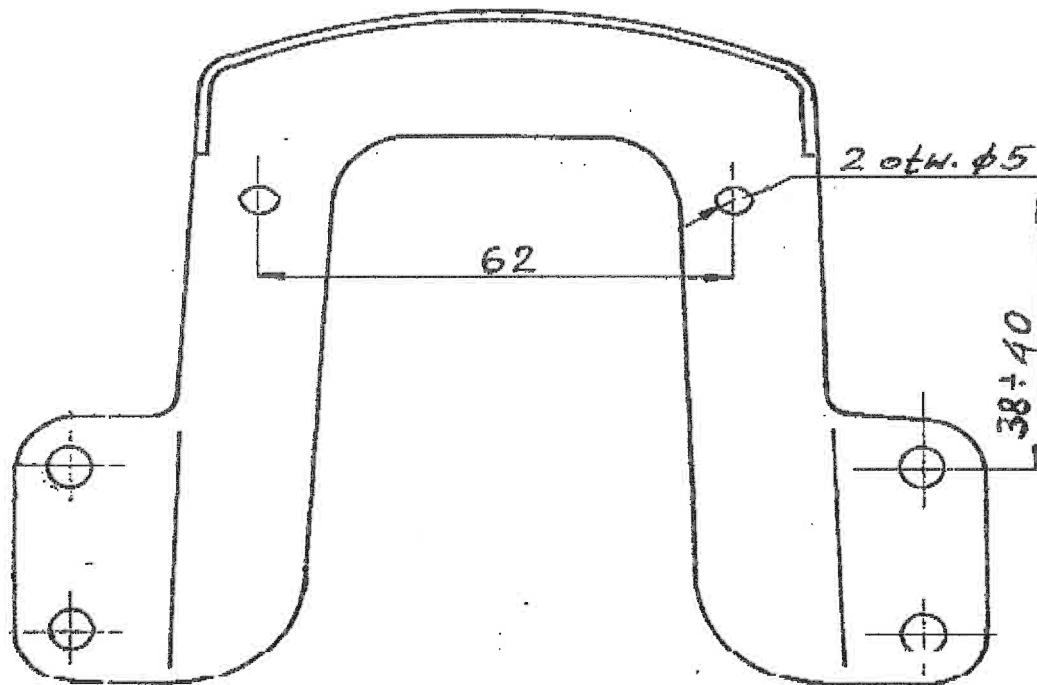
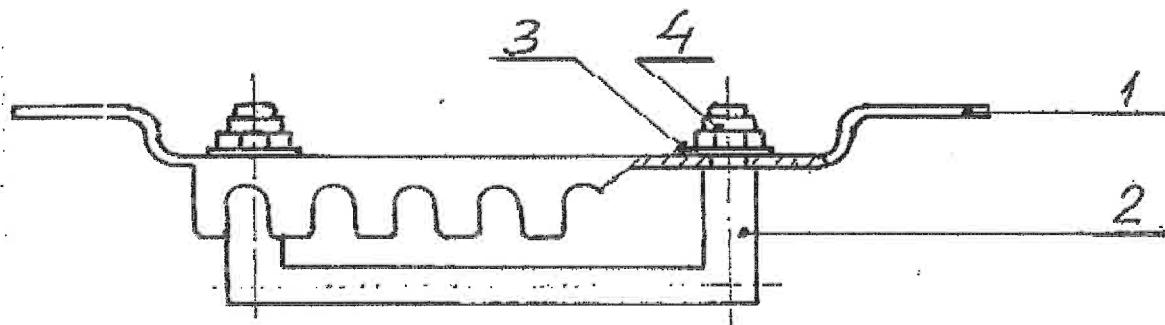
S K E T C H " A "

Part "A" - It has been found that the less experienced pilot may set the trimming spring beyond the allowed deflection range. In this case, on certain gliders, the control column free deflections for aileron control could be limited.

To console detail 1 (drawing No B2-10.25.02) , fixing the position of trimming spring , a bow detail 2 , preventing the trim deflection beyond the allowed range , has been added . In the console prepare openings for bow installation , and next install the bow according to sketch " A " .

1	Console	xxxx
2	Bow	1 pc
3	Washer S, 3x1	2 pcs
4	Nut MS	2 pcs

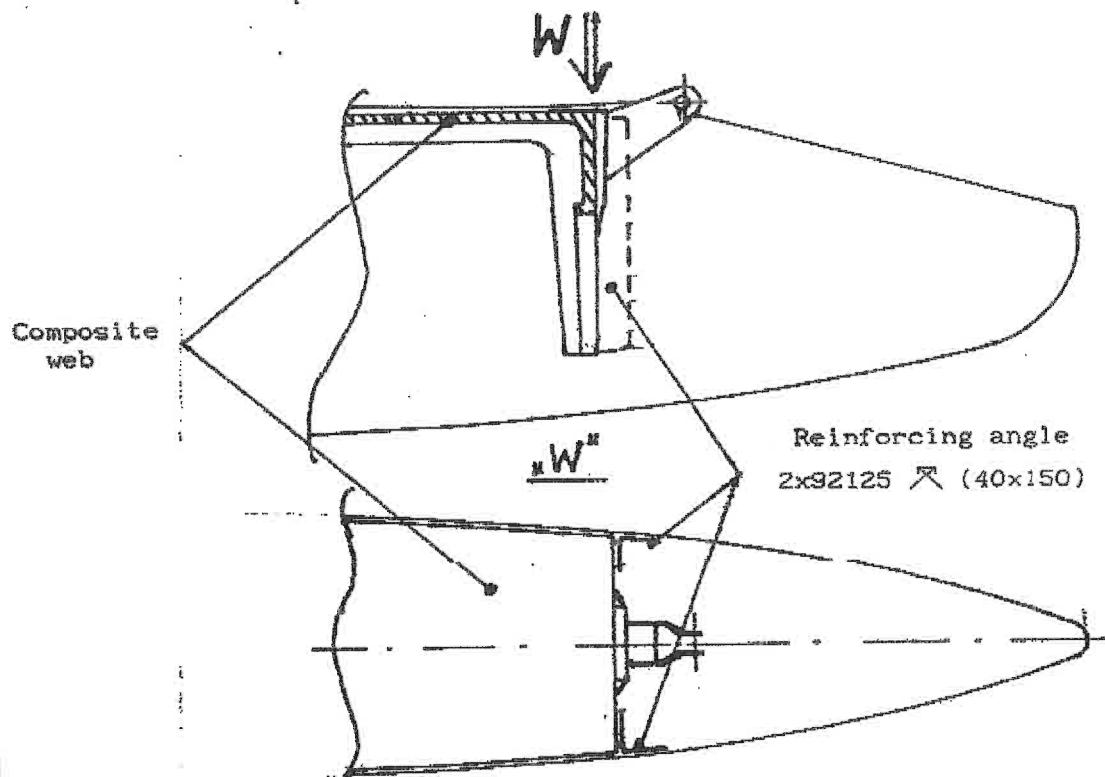
SKETCH "B"

Part "B" - In operation it has been found that the to energetic ground handling, employing the hook and handle located in fuselage tail may lead to damages of glue bonding, joining the skeleton structure with fuselage shell (see sketch "B").

For laminating operations the accessible epoxy resin system, one being attested for application in aviation structures, must be used - according to the recommended rules of proceeding with this resin (proportions, conditions for laminating operations, curing). To the customer order we can forward the necessary amount of EP60 resin, and other materials for laminating.

To strengthen the bonding between B2-21.00.03 web and fuselage shell introduction of angles , of 92125 Interglass glass fabric , glued with epoxy resin acc. to the following sketch is recommended .
