**SERVICE BULLETIN  
No: BO-23/2016 MDM-1 FOX**

DESIGNATION-TYPE/MODEL: MDM-1 FOX

All MDM-1 FOX model gliders,  
variants: MDM-1 FOX, MDM-1P FOX-P, MDM-1M FOX  
replacement of control stick at front seat

Bielsko-Biała, 16.02.2016

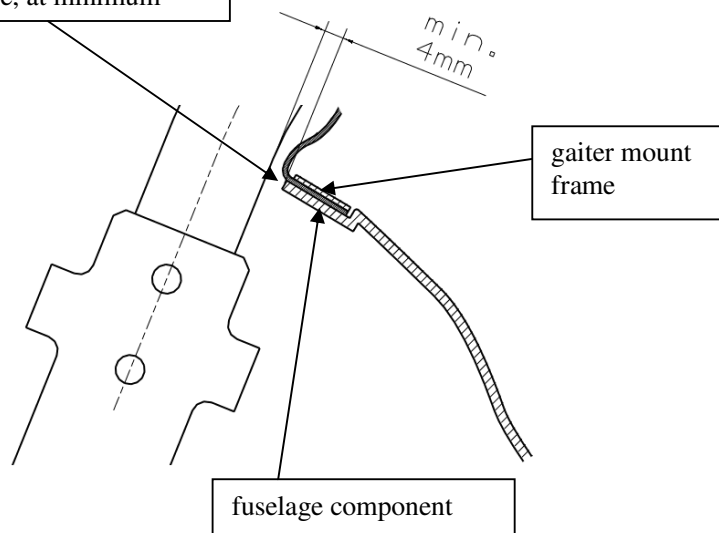
Verification of control stick clearance

With control circuits assembled, check & adjust as necessary the available deflection of control surfaces – see item 2.2 CONTROL SYSTEMS ... in Technical Service Manual. Measure the clearance between tube of control stick at front seat and the rear rim of fuselage cut-out & cover at stick mount, for stick maximum rearward position (ailerons neutral and maximum Left/ Right deflection). For the clearance below 4 mm – file the rear rim of fuselage components to ensure this minimum value.

remove the gaiter, and file this edge  
to ensure 4 mm clearance, at minimum
