# SERVICE BULLETIN No: BO-23/2016 MDM-1 FOX

DESIGNATION-TYPE/MODEL: MDM-1 FOX

SERIA / NUMBER:	All MDM-1 FOX model gliders, variants: MDM-1 FOX, MDM-1P FOX-P, MDM-1M FOX
CONCERNS:	replacement of control stick at front seat modification described in this Bulletin constitutes Alternative Method of Compliance with Airworthiness Directive EASA No 2015-0182-E
COMPLIANCE TIME:	at the discretion of operator, suggested at the annual/ 100-hour inspection

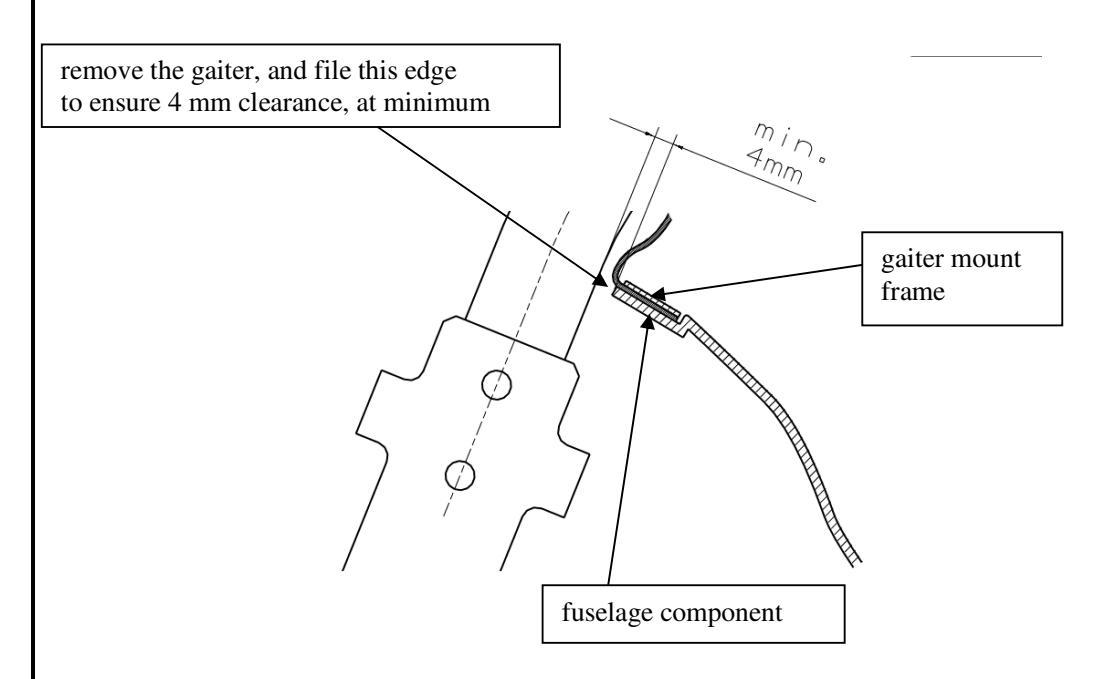
#### Verification of control stick clearance

With control circuits assembled, check & adjust as necessary the available deflection of control surfaces – see item 2.2 CONTROL SYSTEMS ... in Technical Service Manual. Measure the clearance between tube of control stick at front seat and the rear rim of fuselage cut-out & cover at stick mount, for stick maximum rearward position (ailerons neutral and maximum Left/ Right deflection). For the clearance below 4 mm – file the rear rim of fuselage components to ensure this minimum value.

2. After installation, make a verification of clearance between the control stick tube and the rim of fuselage seat pan and gaiter mount frame (procedure cited in the next page). Such verification is to be repeated at every annual/ 100-hour inspection of the glider (whichever expires first).
